APPLICATION STORY

Czech Utility Company Uses Optical Gas Imaging to Check for SF₆ Leaks

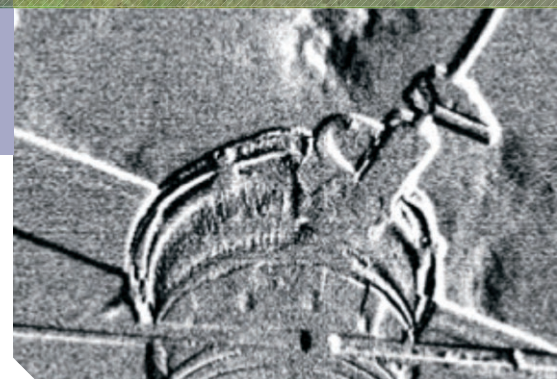
Gas leaks become easily visible thanks to optical gas imaging (OGI) technology

"We tested an optical gas imaging camera on a current transformer that was leaking SF₆ and we immediately realized its potential,"

says Sedláček. "We had tried unsuccessfully to detect the leak with other means, but with the optical gas imaging camera we managed to find out where the problem was located. Following this surprisingly successful demonstration we have purchased the camera and we have not regretted that decision. It has proven to be very effective even within a few months of use."

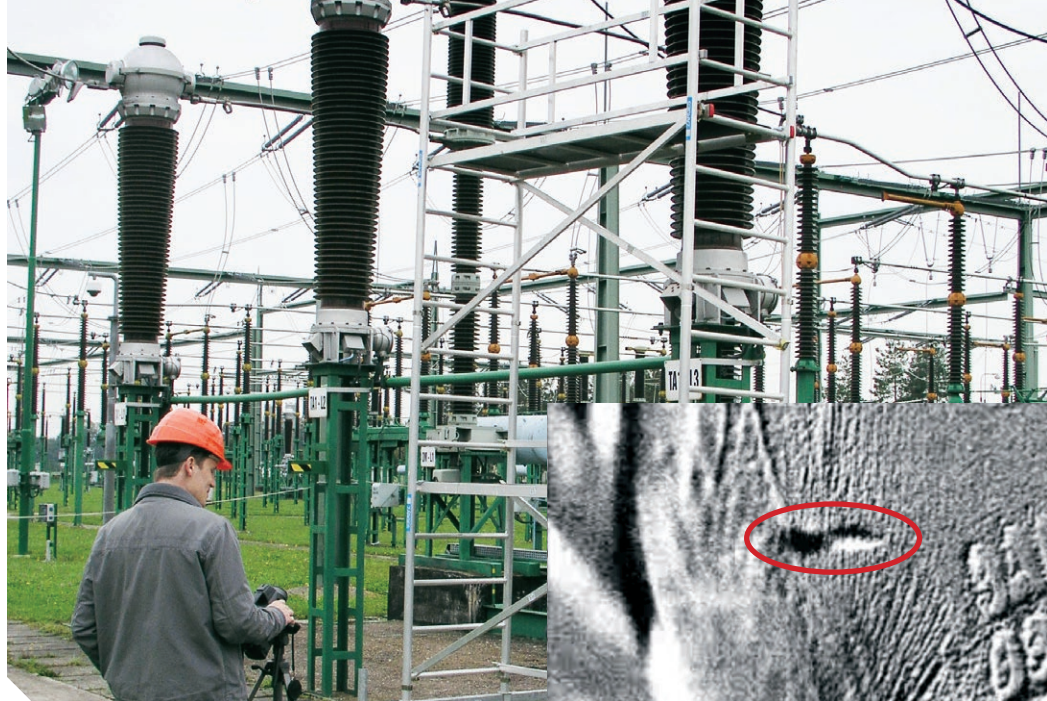
Insulators containing SF₆ gas can be easily surveyed, and any leaks detected, from a safe distance

The main advantage of optical gas imaging when compared with other methods is the detection range, according to Sedláček. "With a sniffer you have to be within just a few millimeters of the leak location to detect the SF₆ leak, but we found that the optical gas imaging camera can detect small leaks from six meters, so it can be used safely while the equipment is under charge. This means that no downtime is required for the inspection, which is a huge advantage for us."
